POWER SYSTEM OPERATING INCIDENT REPORT – LIGHTNING STRIKES IN TASMANIA AND PACIFIC ALUMINIUM POTLINE LOAD REDUCTIONS 21 MARCH 2013

PREPARED BY: Systems Capability

DATE: 7 June 2013

FINAL

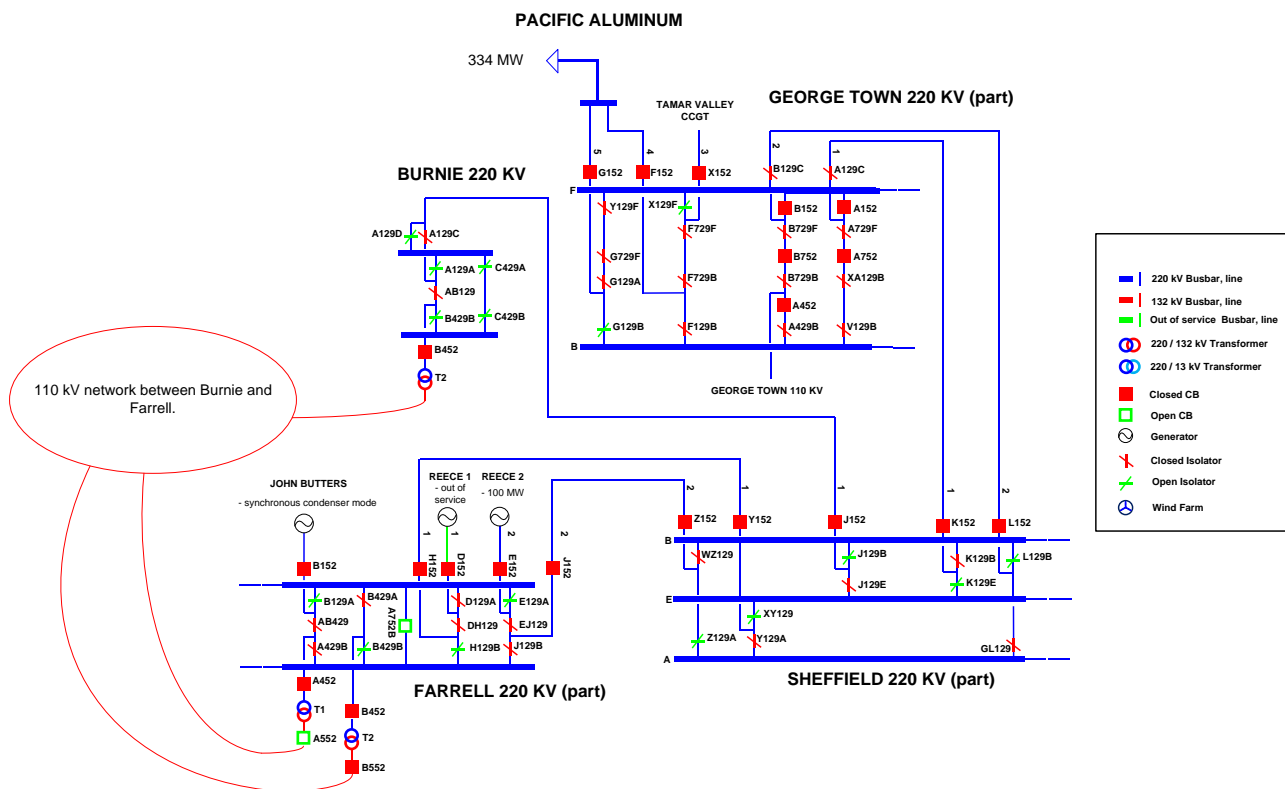
Figure 1- Pre-contingent system conditions prior to the incidents in Tasmania on 21 March 2013

The status of the power system prior to the incident is shown in Figure 1. For clarity only equipment relevant to this incident has been included in the diagram.

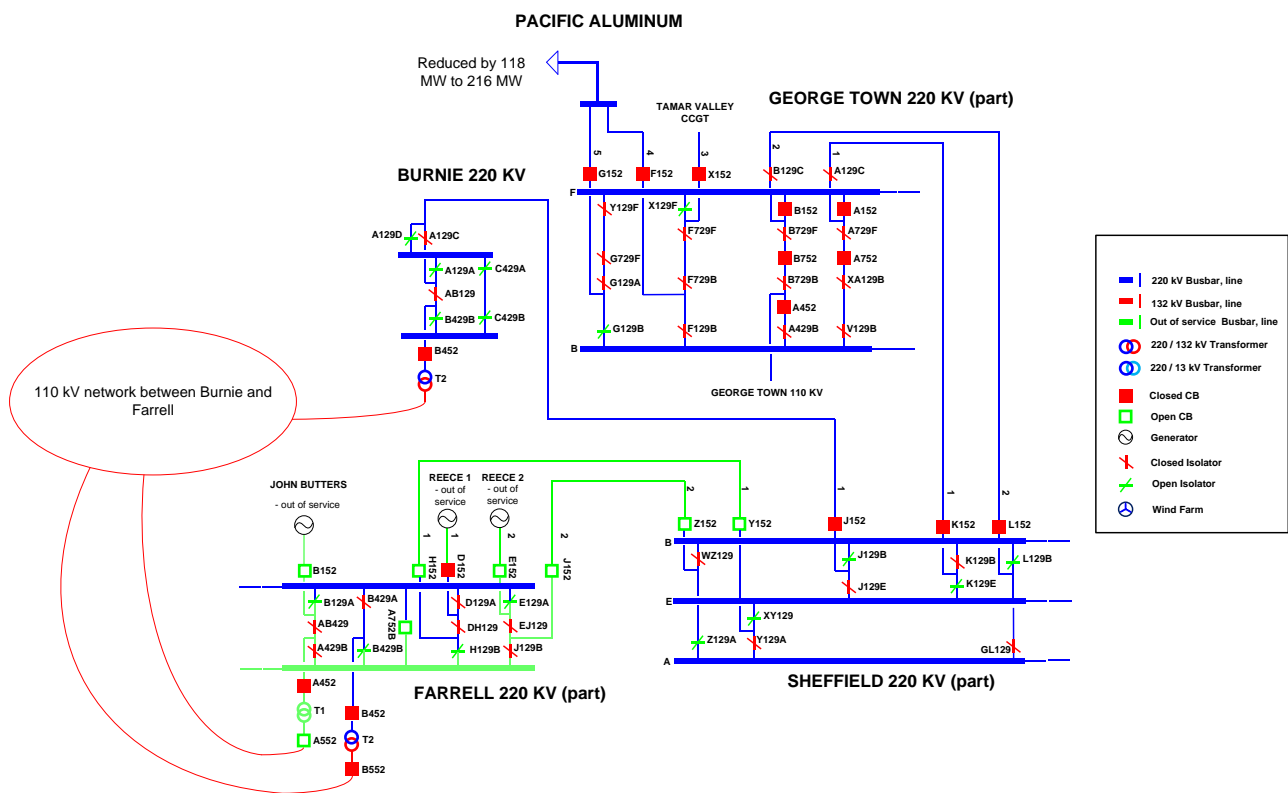
Figure 2:- Status of the power system immediately after the incident 1834 hrs 21 March 2013.

At 1834 hrs 21 March 2013, the Farrell – Sheffield No.1 and No.2 220 kV transmission lines tripped out of service due to a fault associated with a lightning strike². The fault was cleared by protection within approximately 80 milliseconds.

As a result of the trips, generating units Reece Unit 2 (100 MW of generation) and John Butters (operating as a synchronous condenser) were islanded and therefore also tripped out of service. The Tasmanian Over-Frequency Generation Shedding Scheme (OFGSS) operated to open the circuit breakers at the Farrell end of the generator transmission lines³. Approximately 11 seconds after the fault was cleared Pacific Aluminium reduced in load by 118 MW, on potline No.4.

The status of the power system immediately after the incident is shown in Figure 2.

The Farrell – Sheffield No.1 and No.2 220 kV transmission lines were returned to service at 1846 hrs. Load restoration at Pacific Aluminium commenced at 1849 hrs. Generating units Reece Unit 2 and the John Butters were returned to service at 1953 hrs and 1957 hrs respectively.

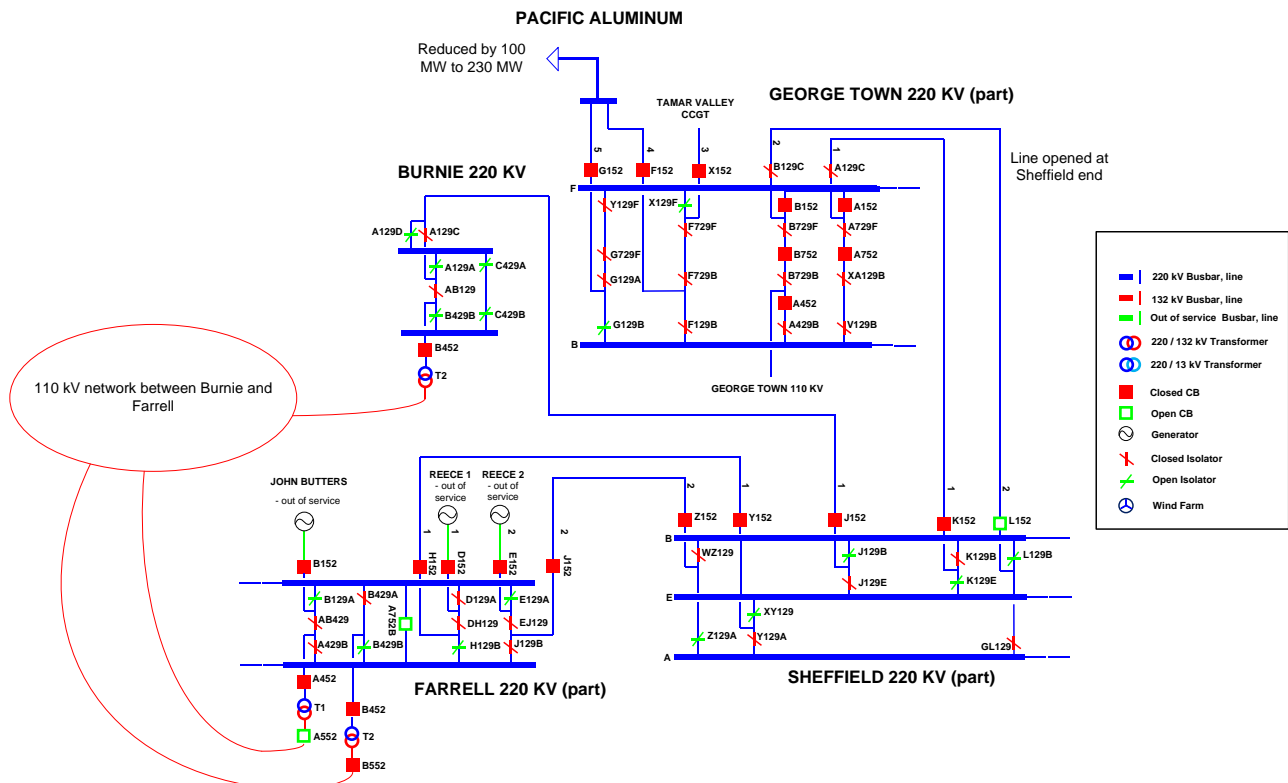
Figure 3:- Status of the power system immediately after the incident 1901 hrs 21 March 2013.

At 1901 hrs 21 March 2013, the George Town - Sheffield No.2 220 kV transmission line tripped out of service due to a fault associated with a lightning strike⁴. The fault was cleared by protection within approximately 80 milliseconds.

Following fault clearance, both circuit breakers at the George Town end of the transmission line automatically reclosed. Approximately 11 seconds after the fault was cleared Pacific Aluminium reduced in load by 100 MW, on potline No. 3.

The status of the power system immediately after the incident is shown in Figure 3.

The 220 kV CB L152 at Sheffield was manually closed at 1902 hrs, returning the George Town - Sheffield No.2 220 kV transmission line to service. Load restoration at Pacific Aluminium commenced at 1908 hrs.

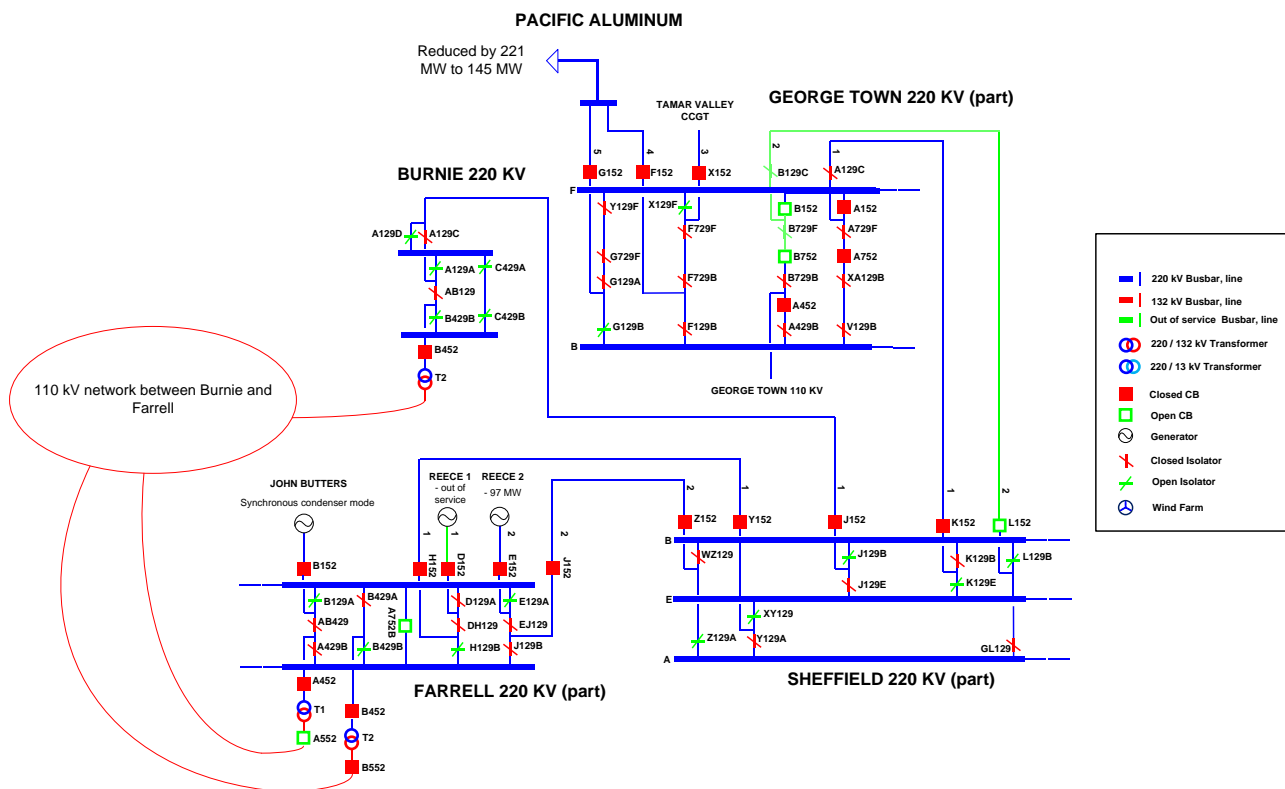
Figure 4:- Status of the power system immediately after the incident 2057 hrs 21 March 2013.

At 2057 hrs 21 March 2013, the George Town - Sheffield No.2 220 kV transmission line tripped out of service due to a fault associated with a lightning strike⁵. The fault was cleared by protection within approximately 80 milliseconds.

While the fault was being cleared, Pacific Aluminium reduced in load by 119 MW on potline No. 4. Approximately 1 second after the fault was cleared Pacific Aluminium reduced in load by 102 MW, on potline No. 3.

The status of the power system immediately after the incident is shown in Figure 4.

The load reductions at 1901 hrs and 2057 hrs were due to emergency shutdown relays at Pacific Aluminium operating as a result of the voltage drop during the fault. The emergency shutdown relays are supplied by battery banks. The battery banks are supplied by battery chargers; and the battery chargers tripped during the fault. Due to the age of the battery banks, when the battery chargers tripped the DC voltage supplying the emergency shutdown relays dropped to a level seen as loss of voltage to the relays. The fail-safe design of the emergency shutdown relays tripped the potlines.

An attempt was made to re-energise the George Town - Sheffield No.2 220 kV transmission line via 220 kV CB L152 at Sheffield. 220 kV CB L152 at Sheffield tripped approximately six seconds later and the transmission line remained out of service until the line was patrolled.

The battery banks supplying the emergency shutdown relays have subsequently been replaced by Pacific Aluminium. On 9 April 2013, AEMO issued Market Notices 42118 and 42119, advising the market that the reclassifications associated with Pacific Aluminium had been cancelled.
