Power System Operating Incident Report – Trip of Callide C Units on 21 October 2013

PREPARED BY: AEMO Systems Capability

DATE: 7 January 2014

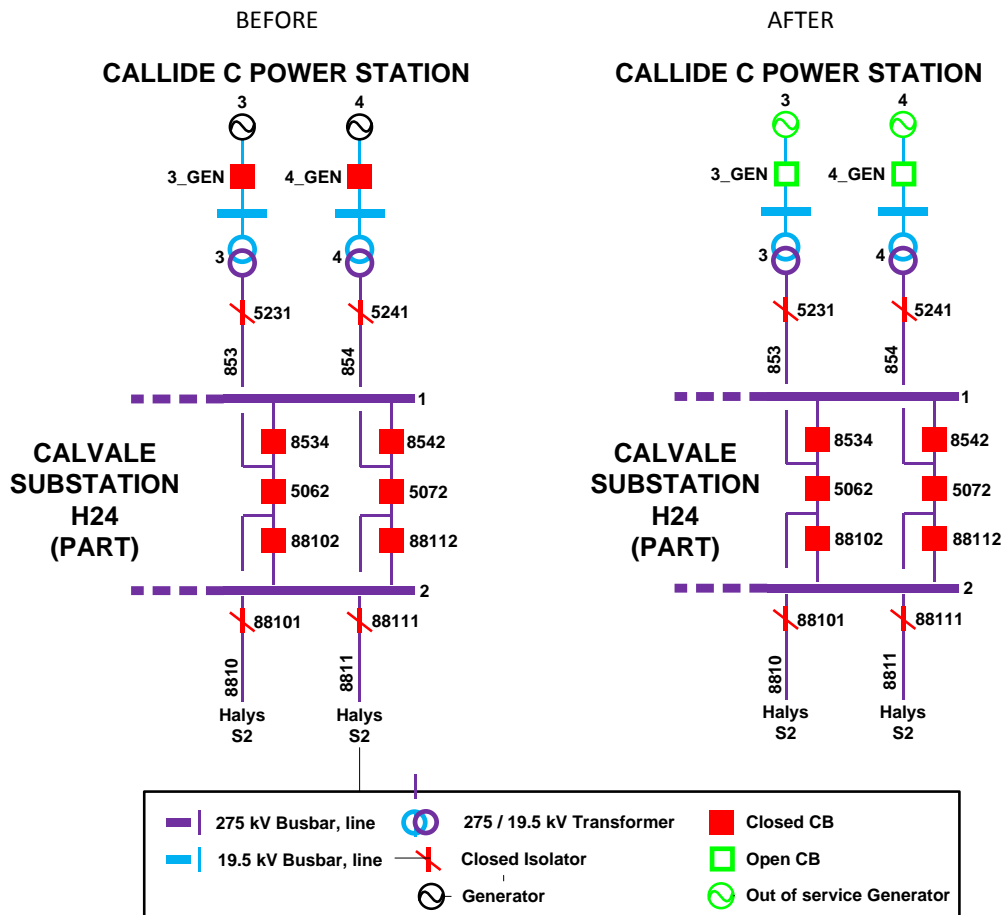
Figure 1 – Power System Diagram

The status of the power system before and after the incident is shown in Figure 1. For clarity only equipment relevant to this incident has been included in the diagrams. The diagram shows both Callide C units in service before the incident and out of service after the incident.
