TRIP OF BOTH 330 KV TRANSMISSION LINES SUPPLYING INGLEBURN SUBSTATION: 20 NOVEMBER 2015

REVIEWABLE OPERATING INCIDENT REPORT UNDER THE
NATIONAL ELECTRICITY RULES

Published: August 2016

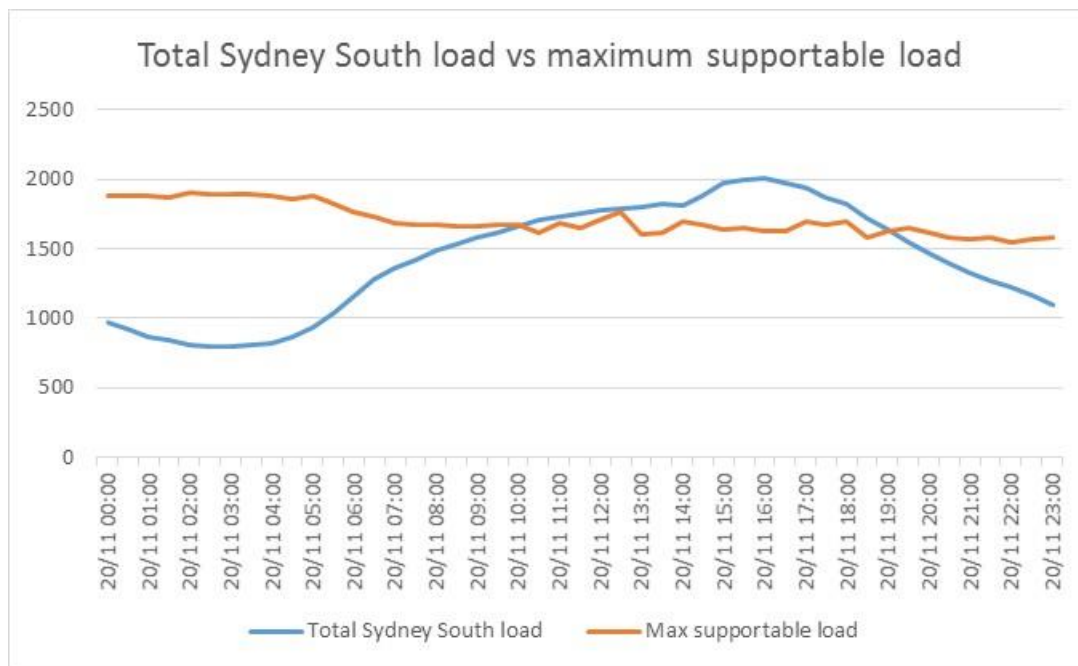
Figure 1 – Sydney South load

After this event AEMO conducted analysis¹³ based on the contingent loss of the Sydney West – Liverpool 30 Line¹⁴ to determine the maximum supportable demand at Sydney South based on voltage levels of at least 297kV. The results, shown in Figure 1 indicate that post-contingent voltage levels in the area would have been below 297kV from around 1030 – 2000hrs¹⁵, which indicates that based on the minimum voltage levels supplied by TransGrid, the power system would not have been in a secure operating state for this period.

Discussion with TransGrid at the time indicated that voltages lower than 297kV would be acceptable and would be unlikely to result in a voltage collapse situation. Previous experience has shown this to be the case. It should be noted that with respect to voltage levels, there is no clear or exact delineation between acceptable and non-acceptable levels.

Based on knowledge gained from this incident, AEMO will now consider the combined outage of 18 line and 13 line as a high impact outage under conditions of high demand¹⁶.

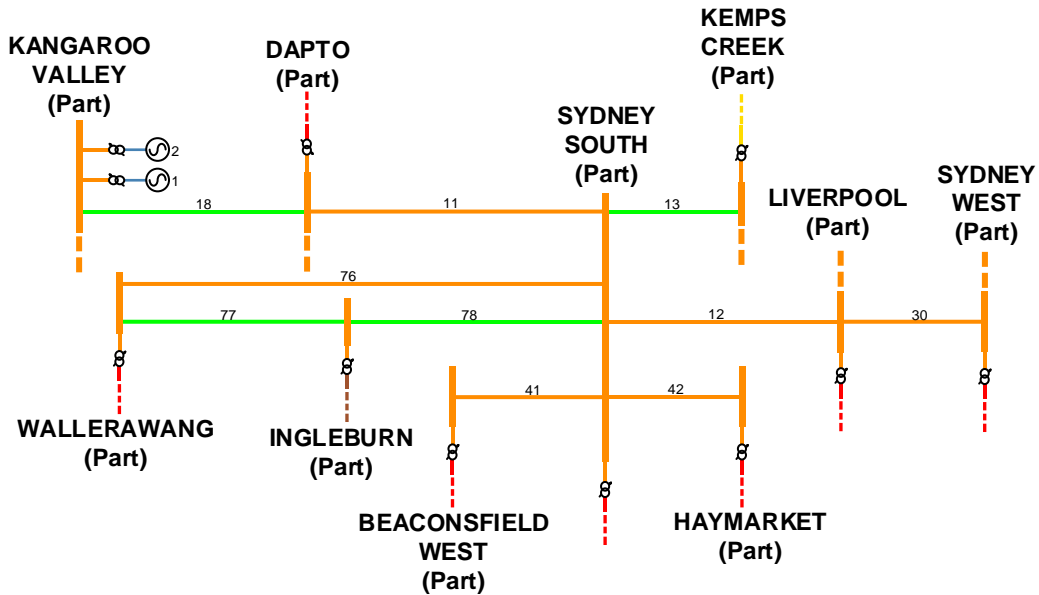
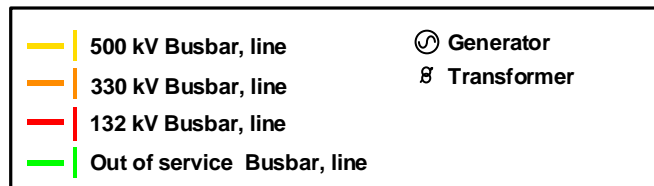
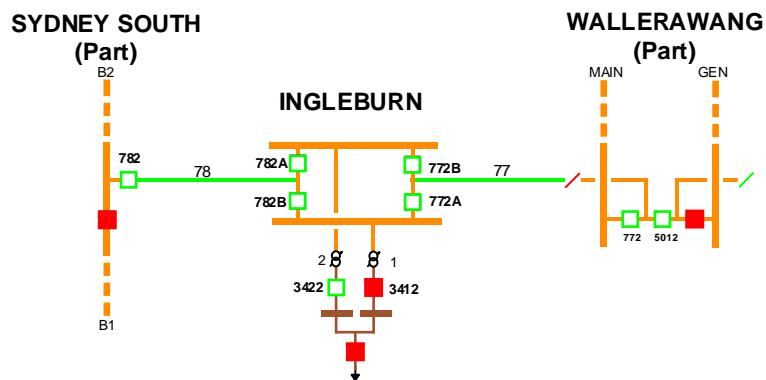
APPENDIX A. – POWER SYSTEM DIAGRAM

One phase of a 330kV CT associated with CB 772B at IS failed explosively. This resulted in the trip of 77 Line and Transformer No.2 at IS, leaving the load at IS fed via 78 Line and Transformer No.1. This is an expected outcome for this type of fault.

Three seconds later, 78 Line tripped due to a phase to earth fault resulting in the loss of all customer load at IS. The trip of 78 Line was due to the smoke/debris cloud from the initial fault on the CT at IS.

Subsequently 77 Line auto-reclosed at IS (CB 772A) and then tripped again and remained out of service. 78 Line auto-reclosed at Sydney South and remained closed. 78 Line remained open at Ingleburn because the auto-reclose function does not operate if there is no voltage at the IS end.

The diagrams below show an overview of the relevant part of the power system and detail of the Ingleburn substation immediately after the event.

77 Line was returned to service at 0001hrs on 22 November 2015 after the failed CT was isolated for repair.

On 9 December 2015 (18 days later), TransGrid replaced the failed CT.
