# FAULT AT TORRENS ISLAND SWITCHYARD AND LOSS OF MULTIPLE GENERATING UNITS ON 3 MARCH 2017

REVIEWABLE OPERATING INCIDENT REPORT FOR THE  
NATIONAL ELECTRICITY MARKET

Published: **10 March 2017**

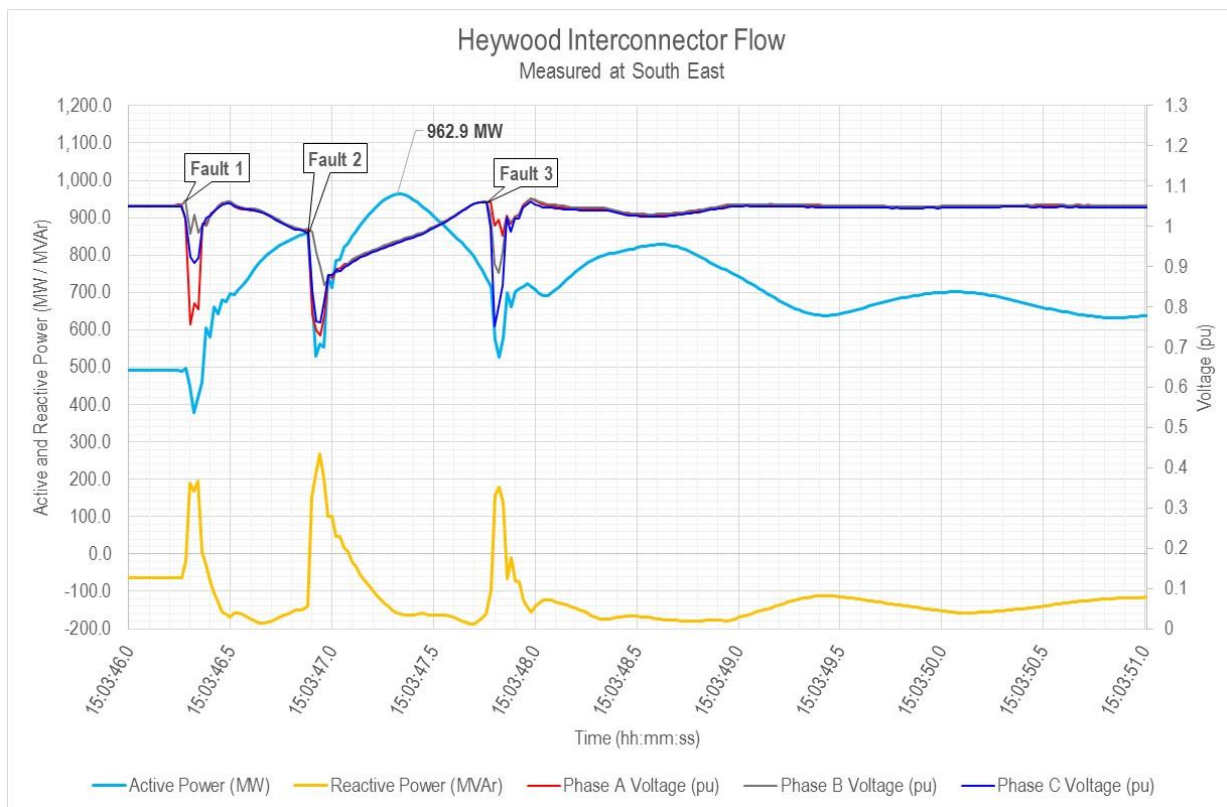
**Figure 1 Heywood Interconnector**

The power flow on the Heywood Interconnector just prior to this incident was 495 MW. Figure 1 shows active power (MW) and reactive power (MVar) and voltages on the Heywood Interconnector, as measured at the SESS in SA.

The faults at the Torrens Island switchyard resulted in the near simultaneous disconnection of 410 MW of generation. This resulted in the power flow on the Heywood Interconnector peaking at 963 MW approximately 380 ms after the second fault, before levelling off at around 600 MW approximately three seconds later.

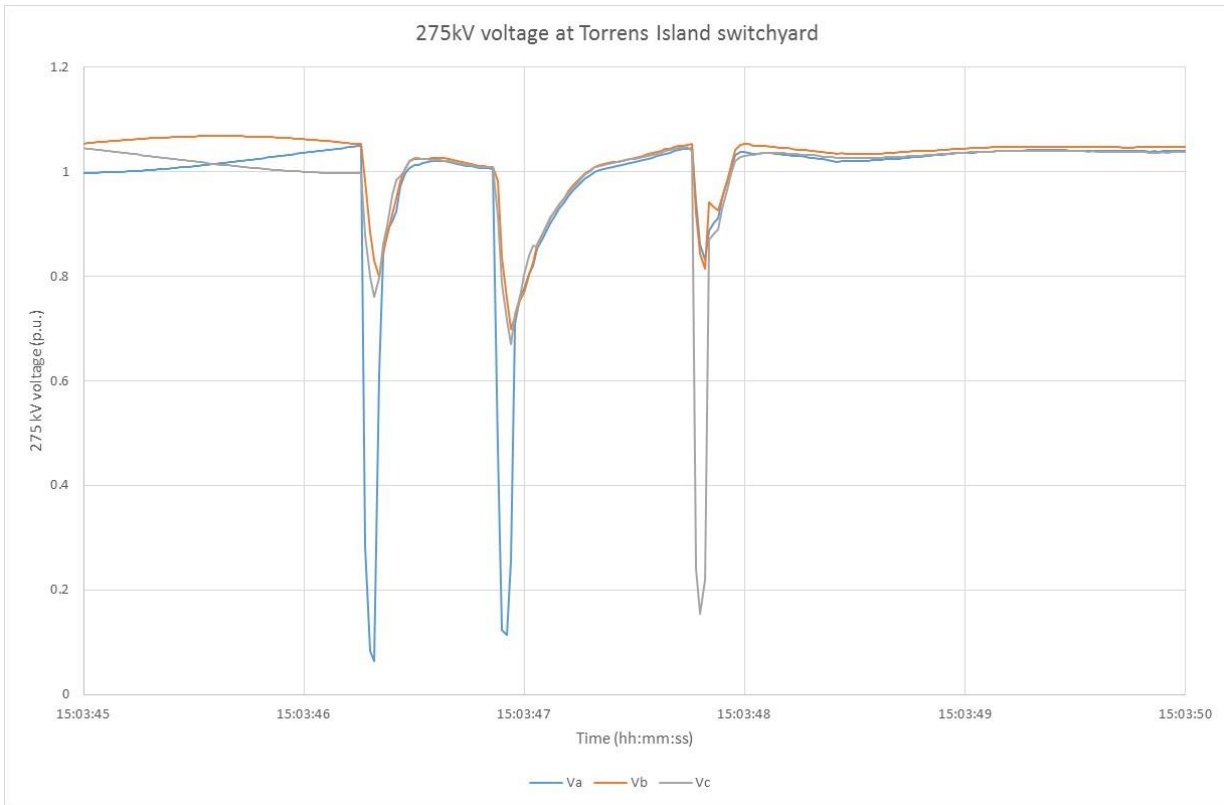
**Figure 2 Voltages at Torrens Island Power Station**

This rapid reduction in the Heywood Interconnector power flow was a result of demand reduction of ~250MW in SA as a result of the voltage disturbance. Voltage levels in the Torrens Island area, which is close to the major load centre of Adelaide, fell to approximately 0.1 pu, as shown in Figure 2.

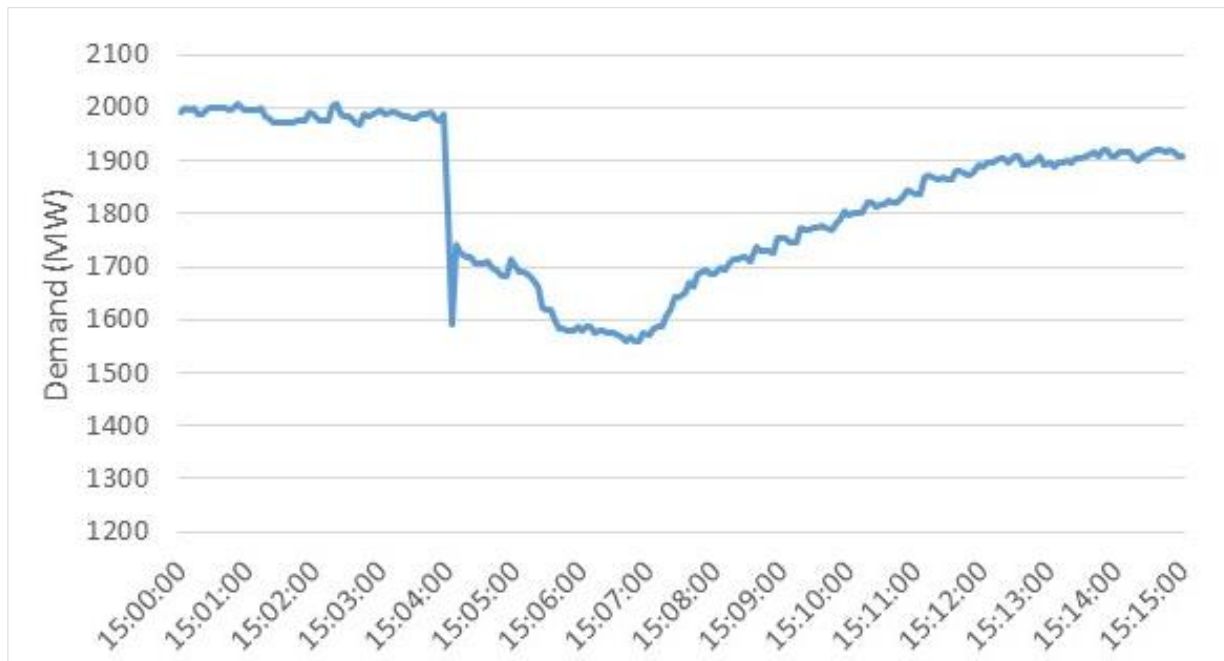
**Figure 3 Demand in SA**

AEMO did not instruct load shedding, and SA Power Networks have confirmed there was no operation of the UFLS scheme.<sup>3</sup> Figure 3 shows the demand reduction in SA immediately after the faults.

As noted above, there was a reduction in SA demand coincident with the faults at the Torrens Island switchyard. The initial reduction was ~400 MW, which rapidly reduced to around 250 MW. Although further analysis is required, AEMO believes, supported by information provided by ElectraNet, that this 150 MW change was a consequence of rooftop PV systems shutting off in response to the voltage disturbance,

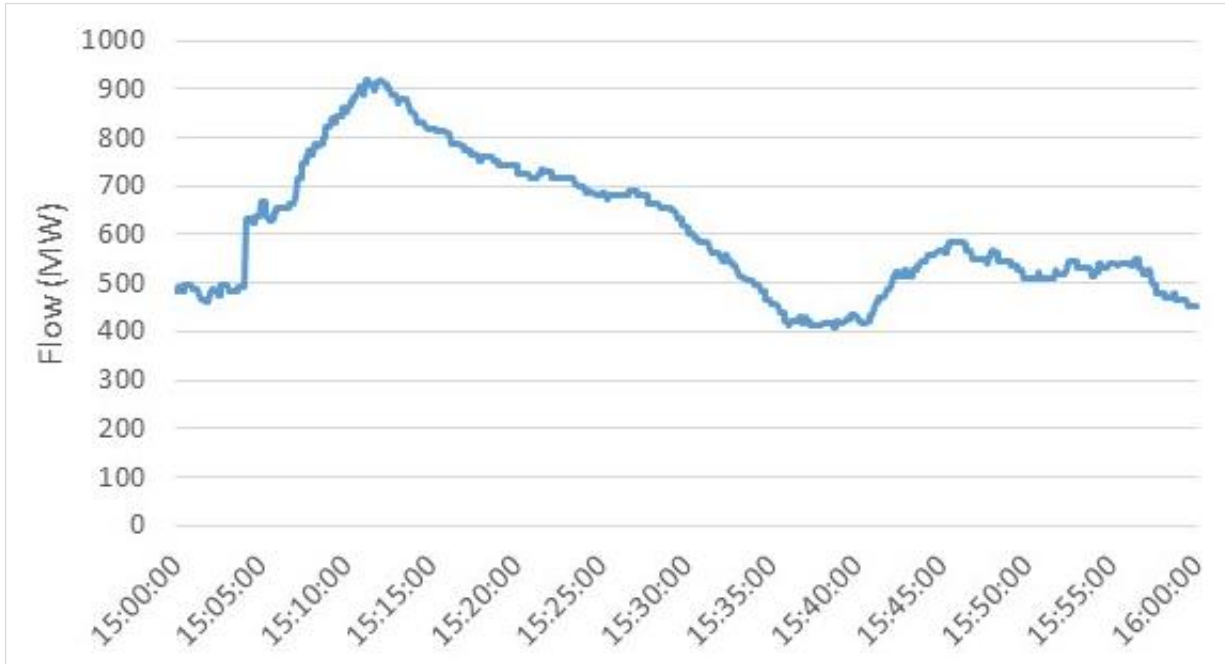
**Figure 4 Heywood interconnector flow**

Although the power flow on the Heywood Interconnector initially recovered to around 600 MW, the loss of a further 200 MW of generation (as the TIPS B2 generating unit and the Pelican Point steam turbine ran back and tripped), combined with increasing demand in SA as load that initially reduced reconnected, resulted in a further increase in the Heywood Interconnector power flow to approximately 918 MW, as shown in Figure 4.

As a result of the increased power flow across the interconnector, and the reduction in on-line generation in SA, AEMO's dispatch process issued start signals to a number of generating units in SA. These generating units synchronised from 1520 hrs. The power flow on the Heywood Interconnector was reduced to within normal limits by 1535 hrs.

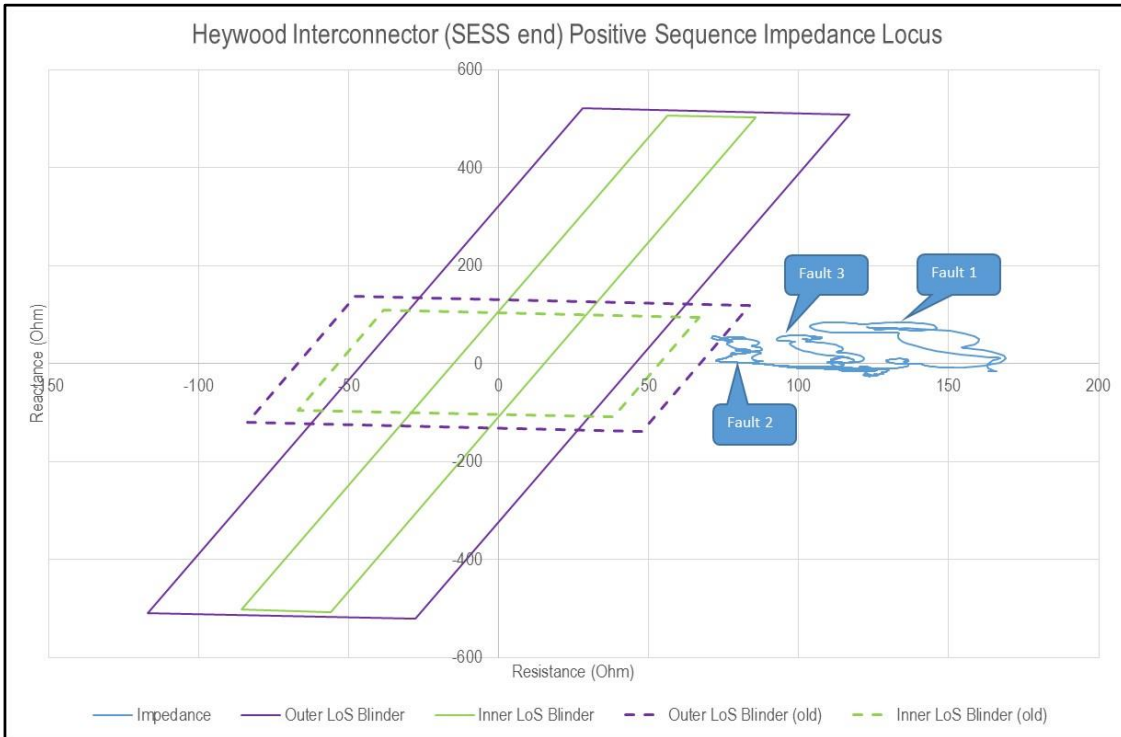
**Figure 6 Loss of synchronism relay on 3 March 2017**

Figure 6 shows the impedance trajectory at SESS against the LoS protection relay settings during the event on 3 March 2017.

The LoS relay characteristics were recently changed as part of the planned works associated with the upgrade of the Heywood Interconnector. The new settings are shown by solid lines, with the old settings in dashed lines.

Figure 6 also shows that, if the impedance trajectory for the 3 March 2017 event had been similar to that on 28 September 2016, then, despite the revised relay settings, the LoS protection would have operated, resulting in the loss of the Heywood Interconnector.

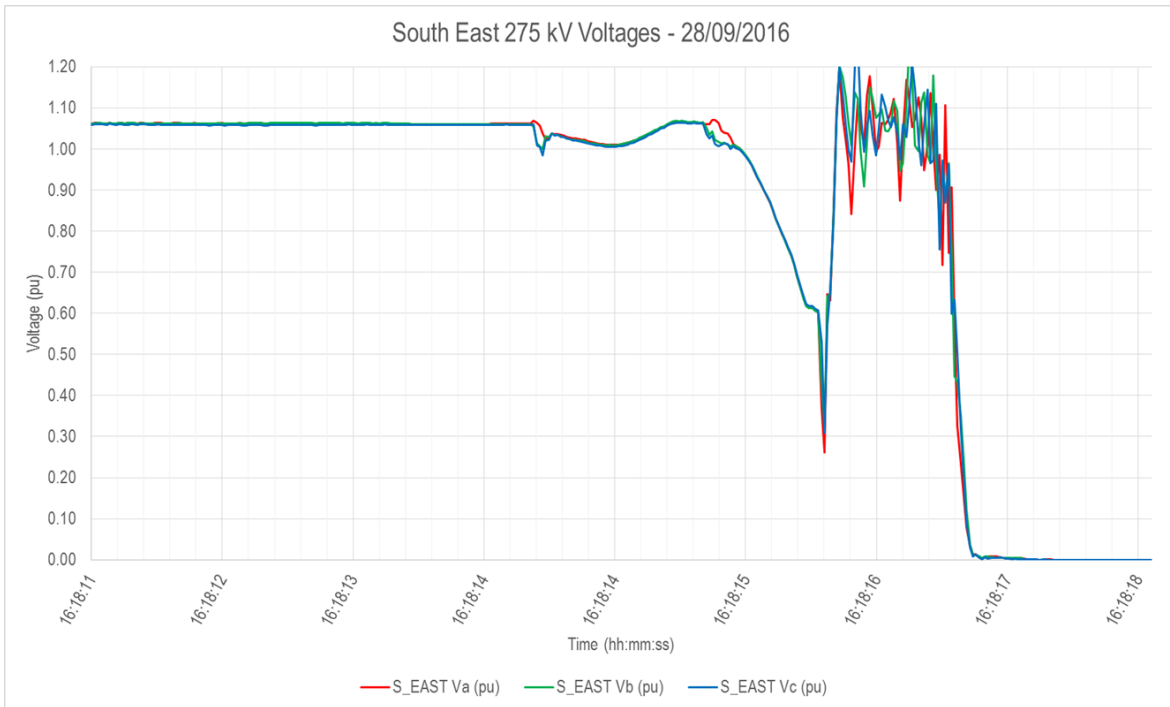
**Figure 7 SESS voltages on 28 September 2016**

- On 28 September 2016, coincident with the increased flow on the Heywood Interconnector, the voltage levels at SESS fell below 0.3 pu, as shown in Figure 7.
- On 3 March 2017, the voltage levels at SESS fell to only approximately 0.75 pu, as shown in Figure 8. Part of the reason for the improved voltage response at SESS on 3 March is the load reduction that occurred as a result of the voltage disturbance caused by the fault.

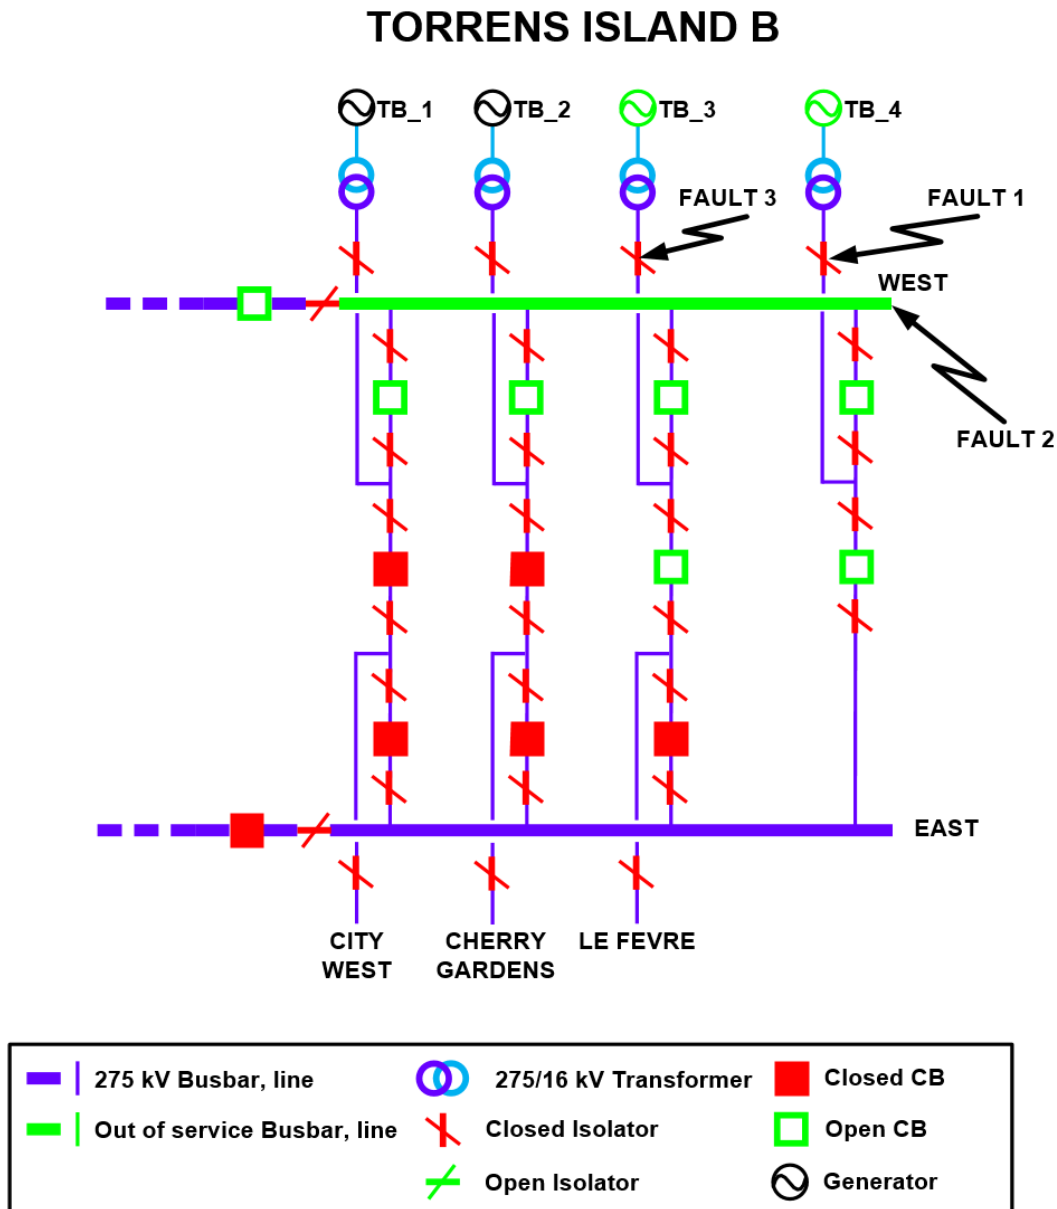
## APPENDIX A. NETWORK DIAGRAM

This diagram shows the status of the switchgear at the Torrens Island switchyard immediately after the third fault.
